In the West, When it Rains, it Slides

Landslides hit Malibu, Calif., causing homeowners to seek methods to keep their property on stable ground.

Malibu landslide

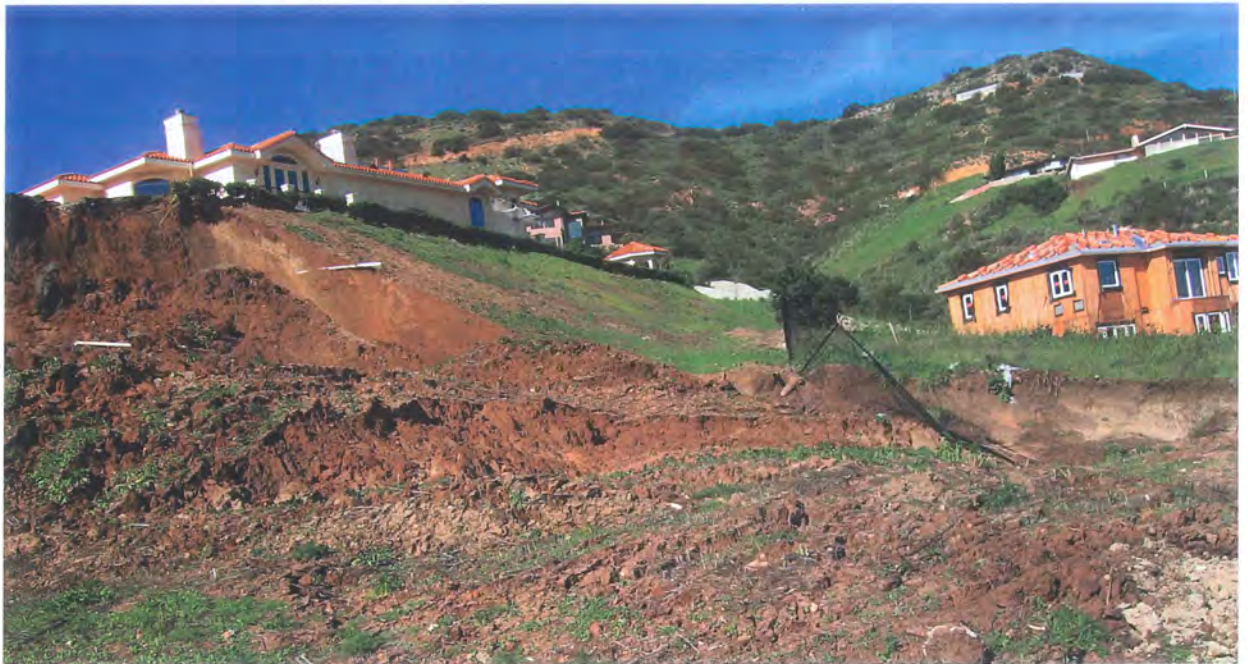
▲ The view, looking up, at a recent landslide in Malibu, Calif. — this house was saved — others in Southern California have not been so lucky.

On Jan. 11, the Pomona office of D.J. Scheffler was contacted to look at a landslide in Malibu that was threatening a guest house. The slide was approximately 50 to 60 feet in width, and the slope height impacted was approximately 70 feet. At the first arrival, the scarp of the landslide was approximately six feet high and extended to approximately 12 feet from the rear wall of the guesthouse.

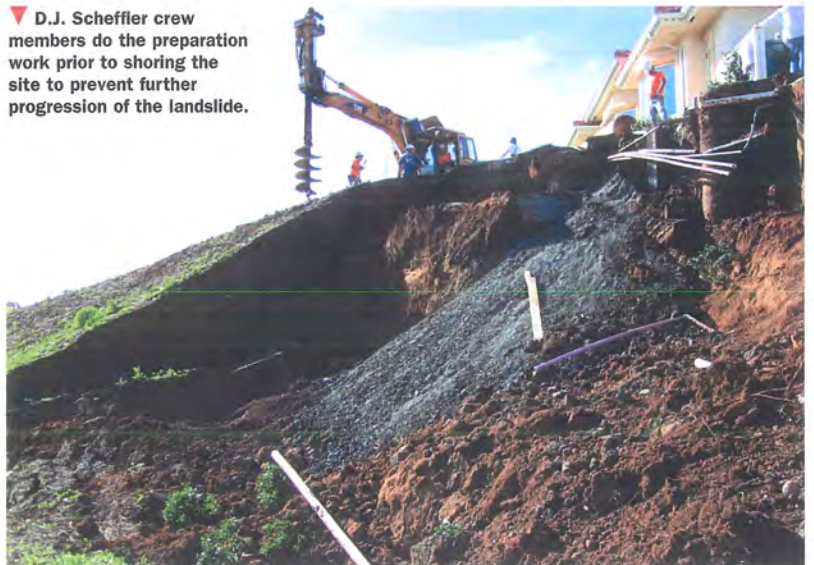
▼ D.J. Scheffler crew members do the preparation work prior to shoring the site to prevent further progression of the landslide.

An emergency permit was issued, and design was progressing as construction began. The shoring wall was constructed based on verbal recommendations without a formal set of plans. On the same day, a drill rig and steel beam reinforcement was mobilized to the site.

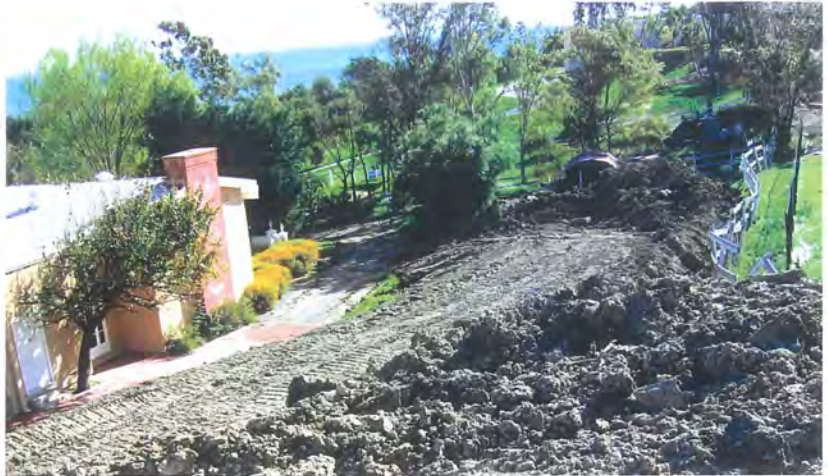
▲ This home in Malibu was saved from a catastrophic landslide during the recent torrential rains on the West Coast thanks to a quick response time from the design team.

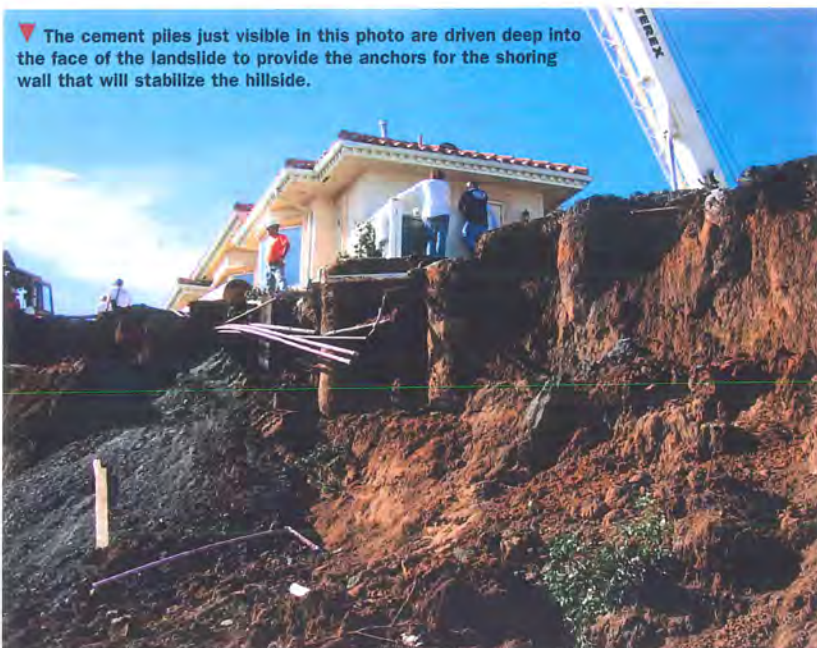
▼ The cement piles just visible in this photo are driven deep into the face of the landslide to provide the anchors for the shoring wall that will stabilize the hillside.

The day after the initial site visit, six steel beam reinforced concrete

soldier piles were constructed. Within the next few days, a total of 14 soldier piles were constructed. As we were finishing the ends of the soldier pile wall the slide movement progressed to the point that the leading face of each of the soldier piles was exposed to a height of approximately 12 feet. The piles were constructed approximately six feet from the rear wall of the guest house.
